# CASE STUDY

#40 ROLLER CHAIN FAILURE INVESTIGATION

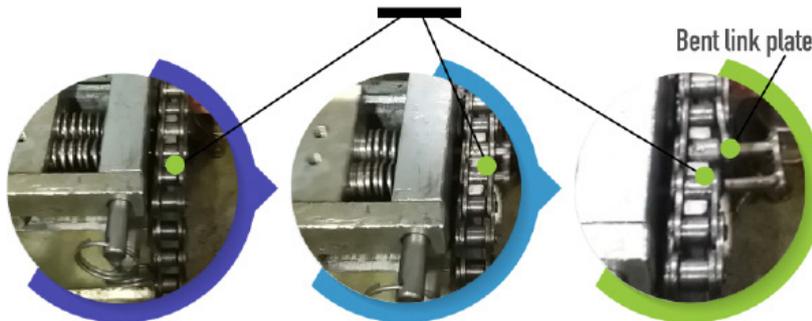
SET-UP DOES NOT SUPPORT THE OUTSIDE SURFACE OF THE CHAIN  
DURING THE DISASSEMBLY PUNCHING OPERATION.

Engineering team did not see the same issue as customer was experiencing. After requesting more information, MPI noticed that the customer current set-up did not support the outside surface of the chain during the disassembly punching operation.

As a result, the force applied to the riveted pins by the two punches is transferred locally throughout the chain assembly. This causes the press-fit bushings (inside link plates) to push out of the link plates resulting in a failure of one or both adjoining pitch assemblies.

Engineering began to work on an alternative machine/fixture that would eliminate the link plate bending issues. MPI's proposal would fully support the pitch assembly being disassembled (punched) and isolate the punching force to only the two pins being pressed out.
